TECHNICAL MEMORANDUM

SUBJECT: March 20, 2017 – LAS Field Observations, Leviathan Mine Site

DATE: March 22, 2017

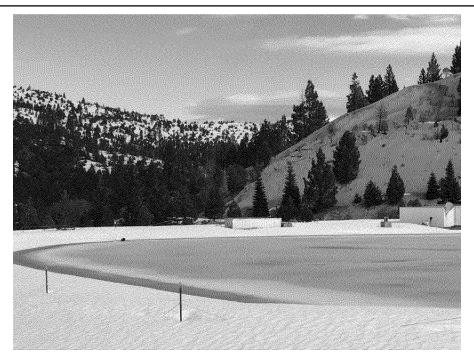
Photograph 1: Pond 1

Water levels in Pond 1, Pond 2S, Pond 2N, and Pond 3 are being actively managed by the Lahontan Regional Water Quality Control Board (LRWQCB) . Pond conditions are shown in Photographs 1 through 5.

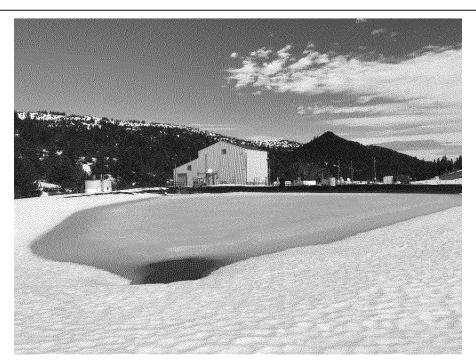
Photograph 4: Pond 4

Pond 4 shows approximately 2.4 feet of freeboard, which equates to approximately 482,000 gallo ns of available storage.
